Fugitive Emission Repair Work Order (RWO)

Туре	Well Site	LSD/NTS	01-35-017-28W4
Name	EECO FOOTHILLS 1-35-17-28	UWI	100013501728W400
Latitude	50.471553	Longitude	-113.738924

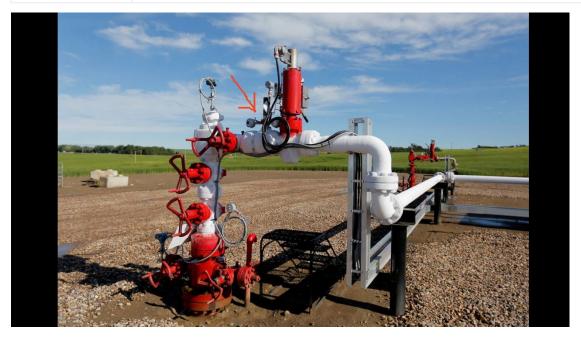
Main Component	Connector	Sub-Component	Grease Injector	
Repair Rec.	Tighten/Reseal Connection	Recommended Urgency	Repair Within 30 Days	
Description	Grease injection niple is venting gas to atm, downstream side			
Emission Notes	Appears to be loose and not b	roken
